PROJECT NO: 8.2752101 (B-3926) COUNTY: WATAUGA

## BRIDGE 35 EB1-A

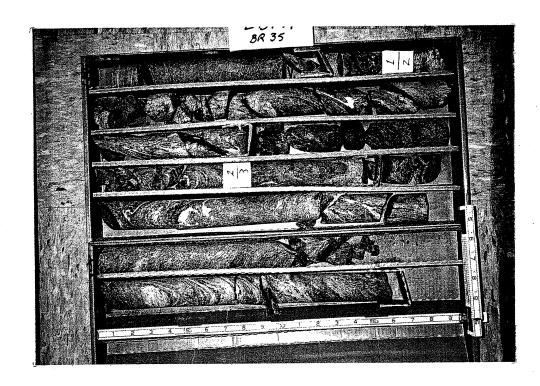
CORE 1: 6.6 - 8.1 REC=80% RQD=40% CORE 2: 8.1 - 13.1 REC=72% RQD=7% CORE 3: 13.1 - 18.1 REC=52% RQD=10% RCC=80% RQD=83%

LAYER 1: 6.6 – 10.1 Boulders

LAYER 2: 10.1 – 17.4 Hard to medium hard, slightly to severely weathered amphibolite. Close-fractured, 35 pieces, longest piece 0.4 feet. Layering steeply dipping and contorted, foliation dips 60-70 degrees. At least 17 joints at 0-20 degrees, 4 joints at 30-60 degrees, moderately rough, coated with Fe- and Mn-oxides. 4 smooth joints at 60-70 degrees. All joints coated with Fe- and Mn-oxides. REC=70% RQD=5%

LAYER 3: 17.4 – 22.9 Hard, very slightly weathered to fresh amphibolite. Close-fractured, 19 pieces, longest piece 1.1 ft. Layering and foliation dip 50-60 degrees, contorted in some places. 6 joints at 0-20 degrees, rough, clean. 3 joints at 30-60 degrees, moderately rough to smooth, coated with Fe-oxide. 1 joint at 70 degrees, smooth, coated with Fe- and Mn-oxides. REC=100% RQD=84%

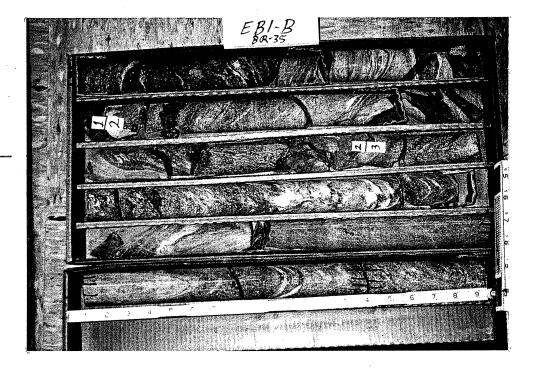
BRIDGE 35 EB1-B

CORE 1: 1.9 – 3.5

CORE 2: 3.5 – 8.5

CORE 3: 8.5 – 12.7

CORE 4: 12.7 – 16.8

REC=75% RQD=44%

REC=46% RQD=32%

REC=98% RQD=48%

REC=88% RQD=85%

LAYER 1: 1.9 – 7.1 Boulders

LAYER 2: 7.1 – 10.4 Hard, very slightly weathered, green to dark gray epidosic amphibolite. Close-fractured, 21 pieces, longest piece 0.6 feet. Very thin, contorted layering dips 40-90 degrees. Poorly developed foliation dips 60 degrees. 13 joints at 20-50 degrees, smooth to moderately rough. 4 joints at 60-80 degrees, smooth. All joints coated with Fe-oxide. REC=94% RQD=41%

LAYER 3: 10.4 – 16.8 Hard, fresh amphibolite. Close- to moderately close-fractured, 11 pieces, longest piece 1.7 feet. Poorly foliated at 60 degrees. 7 joints at 0-20 degrees, moderately rough, clean or with a little Fe-oxide. 1 joint at 60 degrees, smooth, coated with chlorite slickensides. REC=91% RQD=80%
